The Road Inventory of Willapa National Wildlife Refuge Ilwaco, WA

Prepared By:
Federal Highway Administration
Central Federal Lands Highway Division
April 2013

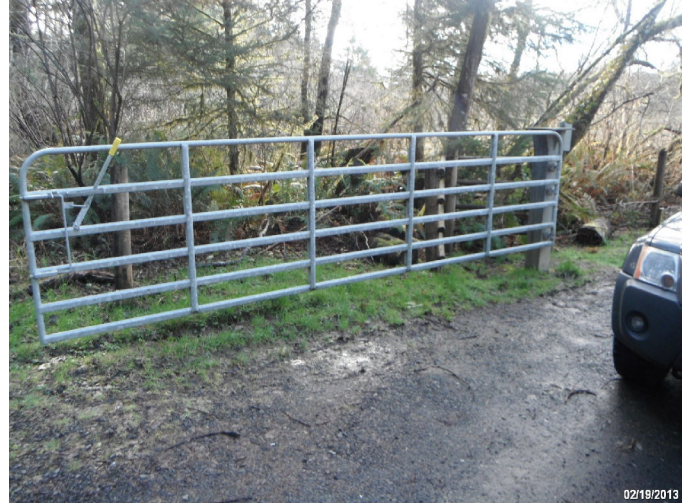
Photo: WILL_C4_0009 Route: 400-001-0.0
Metal Open Rail Gate
Asset# NA

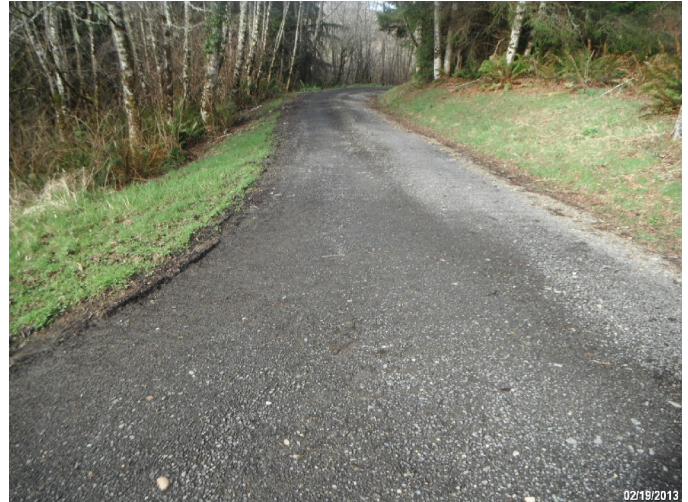
Photo: WILL_C4_0013 Route: 400-002-0.07
Begin Section

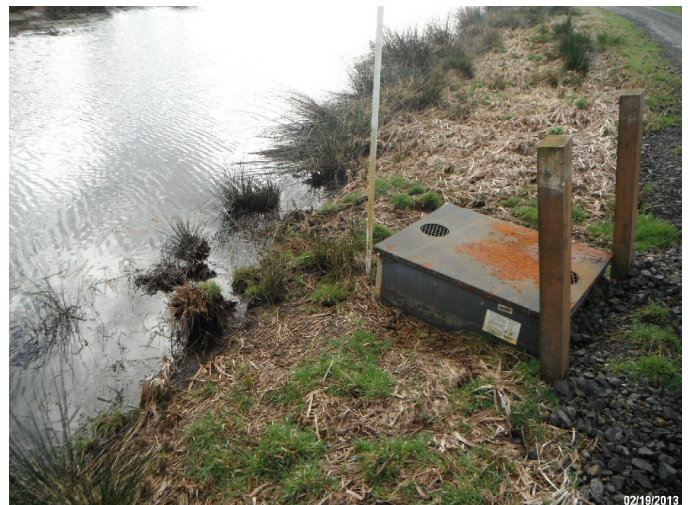
Photo: WILL_C4_0015 Route: 400-002-0.36
Plastic WCS Flashboard Riser 30ft long 24in dia. 2ft deep
New Asset# NA 8-001

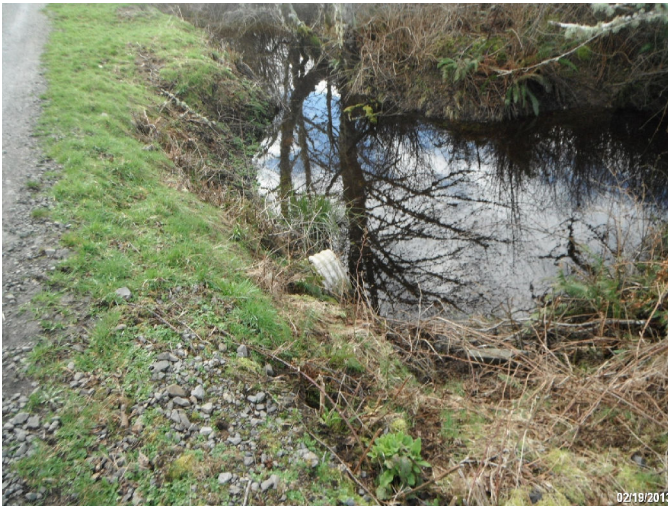
Photo: WILL_C4_0016 Route: 400-002-0.57
Metal Culvert 30ft long 24in dia. 6ft deep
Asset# NA

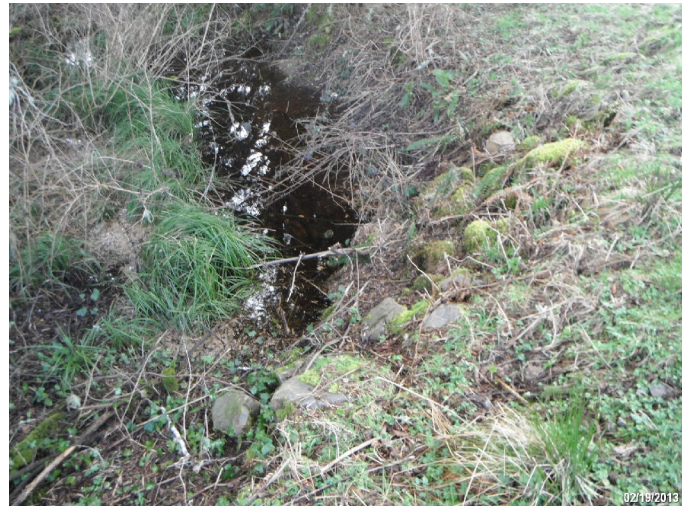
Photo: WILL_C4_0017 Route: 400-002-0.57
Metal Culvert 30ft long 24in dia. 6ft deep
Asset# NA

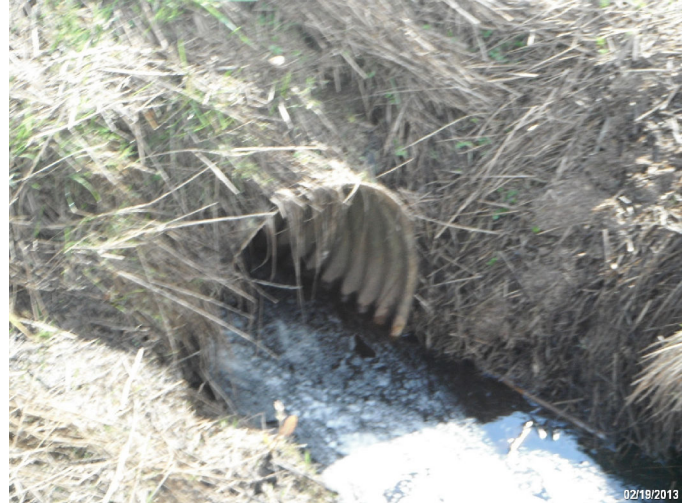
Photo: WILL_C4_0024 Route: 402-001-0.08
Metal Culvert 20ft long 18in dia. 2ft deep
Asset# NA

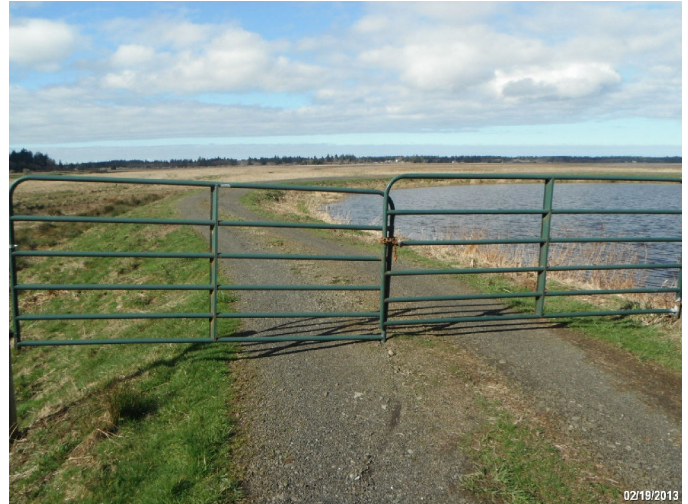
Photo: WILL_C4_0026 Route: 402-001-0.1
Metal Open Rail Gate
Asset# NA

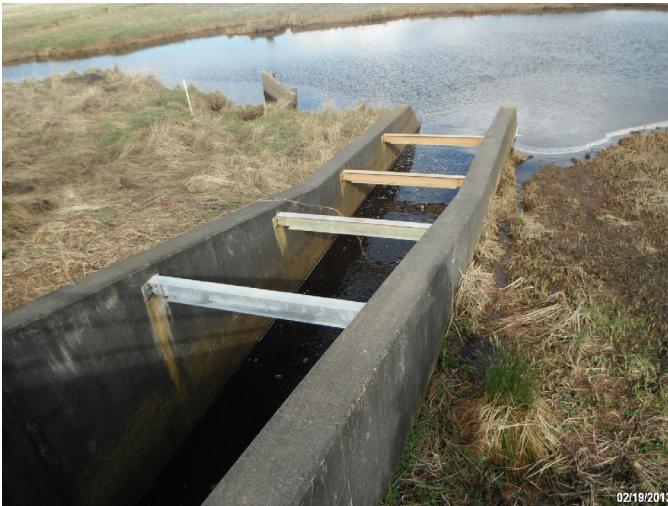
Photo: WILL_C4_0028 Route: 402-002-1.59
Metal WCS Screw Gate 80ft long 0in dia. 1ft deep
6x 10 box Asset# NA

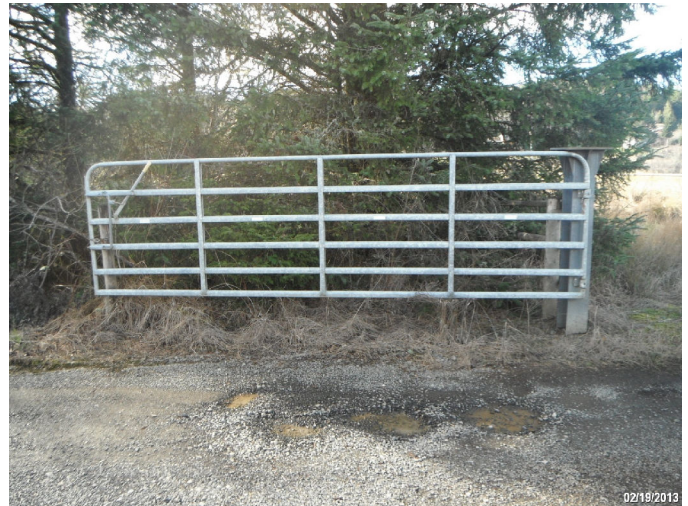
Photo: WILL_C4_0047 Route: 403-001-0.0
Metal Open Rail Gate
Asset# NA

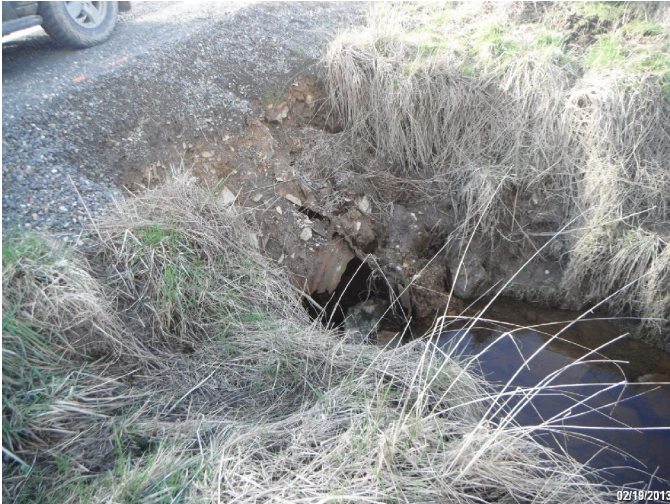
Photo: WILL_C4_0049 Route: 403-001-0.44
Metal Culvert 30ft long 36in dia. 4ft deep
Asset# NA

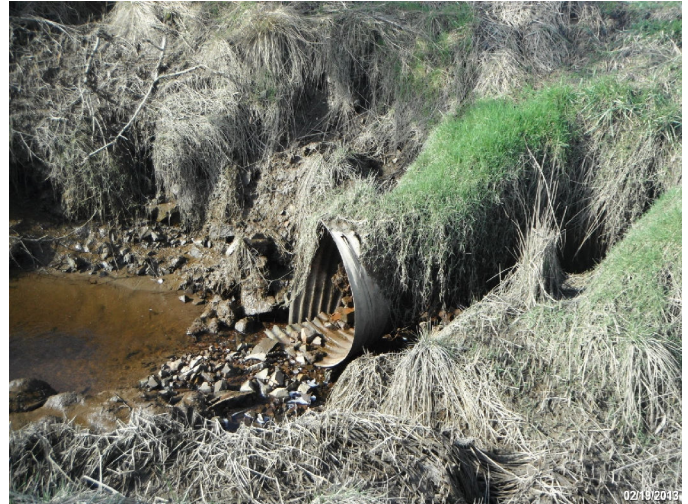
Photo: WILL_C4_0050 Route: 403-001-0.44
Metal Culvert 30ft long 36in dia. 4ft deep
Asset# NA

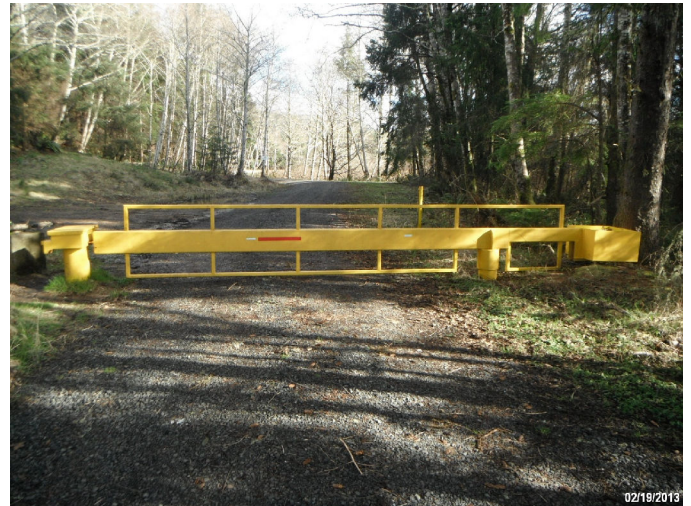
Photo: WILL_C4_0056 Route: 404-001-0.0
Metal Open Rail Gate
Asset# NA

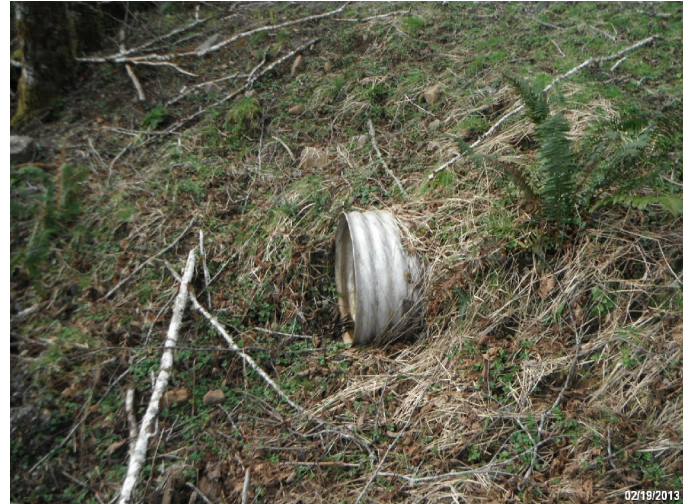
Photo: WILL_C4_0061 Route: 404-001-0.04
Metal Culvert 30ft long 24in dia. 3ft deep
Asset# NA

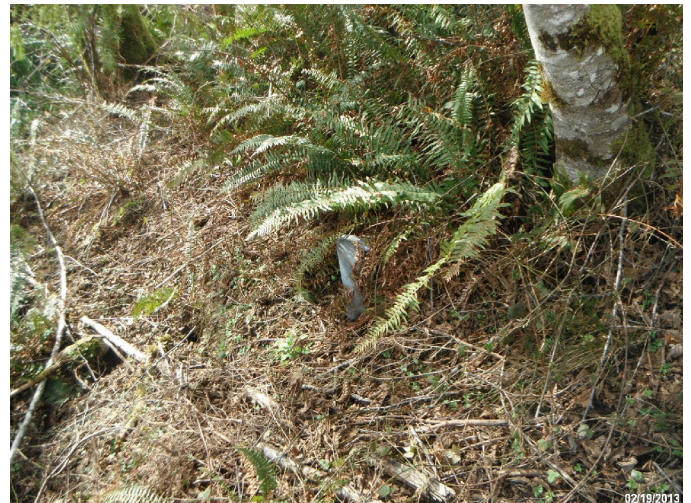
Photo: WILL_C4_0063 Route: 404-001-0.16
Metal Culvert 30ft long 24in dia. 3ft deep
Asset# NA

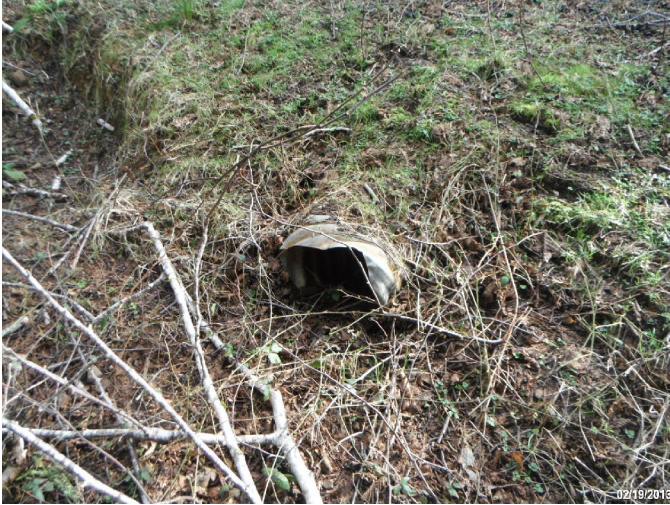
Photo: WILL_C4_0064 Route: 404-001-0.28
Metal Culvert 30ft long 24in dia. 3ft deep
Asset# NA

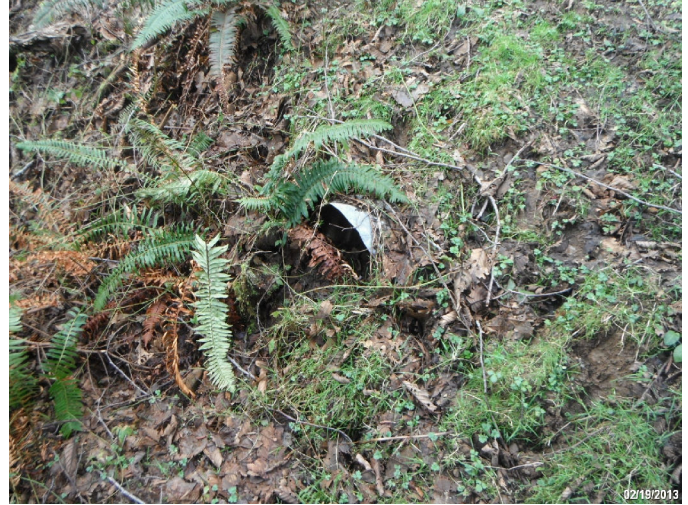
Photo: WILL_C4_0065 Route: 404-001-0.28
Metal Culvert 30ft long 24in dia. 3ft deep
Asset# NA

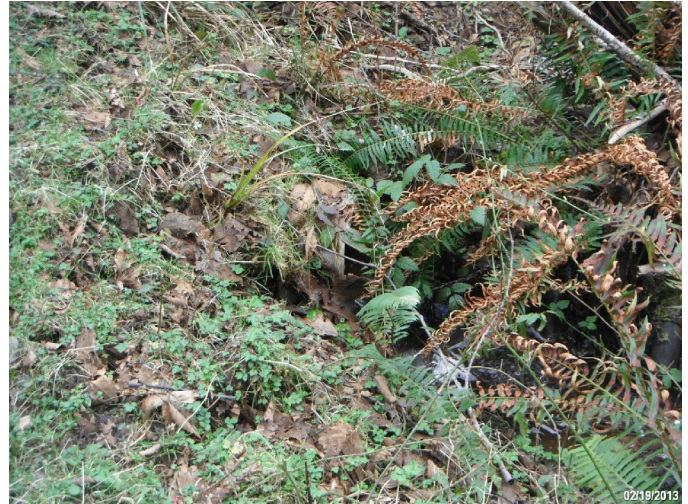
Photo: WILL_C4_0067 Route: 404-001-0.35
Metal Culvert 30ft long 24in dia. 3ft deep
Asset# NA

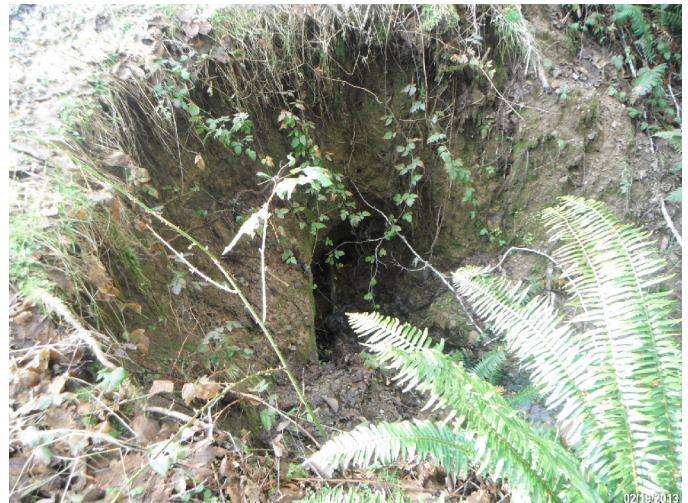
Photo: WILL_C4_0071 Route: 404-001-0.54
Metal Culvert 40ft long 48in dia. 3ft deep
Asset# NA

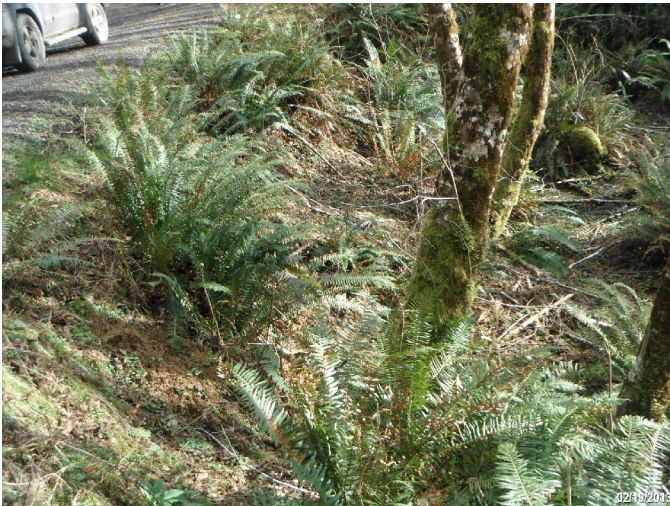
Photo: WILL_C4_0072 Route: 404-001-0.54
Metal Culvert 40ft long 48in dia. 3ft deep
Asset# NA

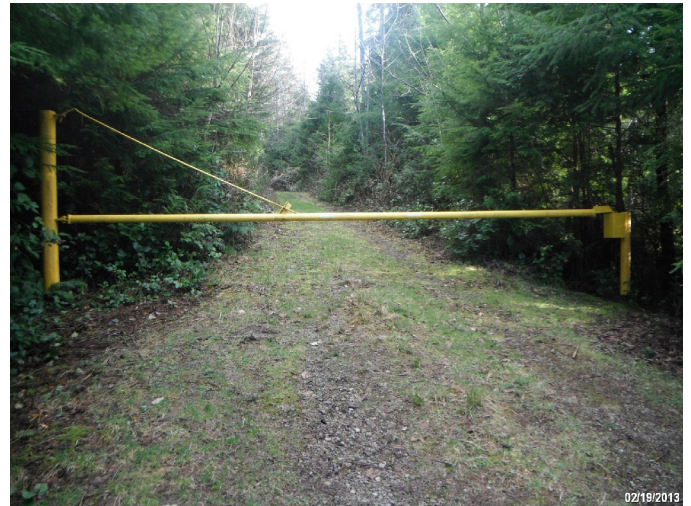
Photo: WILL_C4_0075 Route: 405-001-0.0
Metal Open Rail Gate
Asset# NA

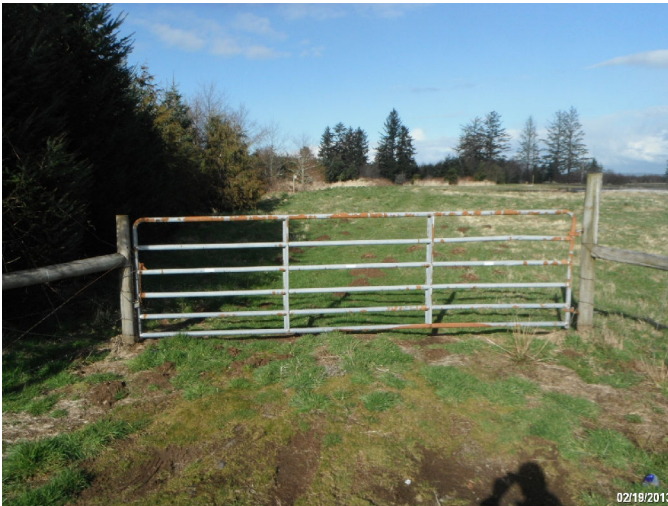
Photo: WILL_C4_0040 Route: 903
Metal Open Rail Gate
Asset# NA

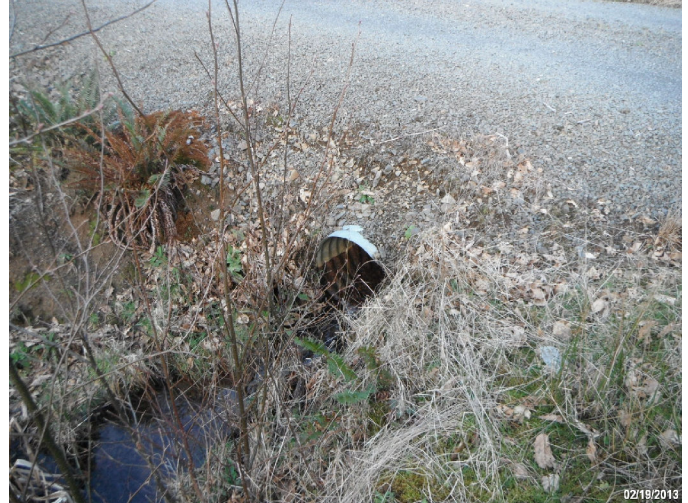
Photo: WILL_C4_0078 Route: 802
Metal Culvert 30ft long 24in dia. 1ft deep
Asset# NA

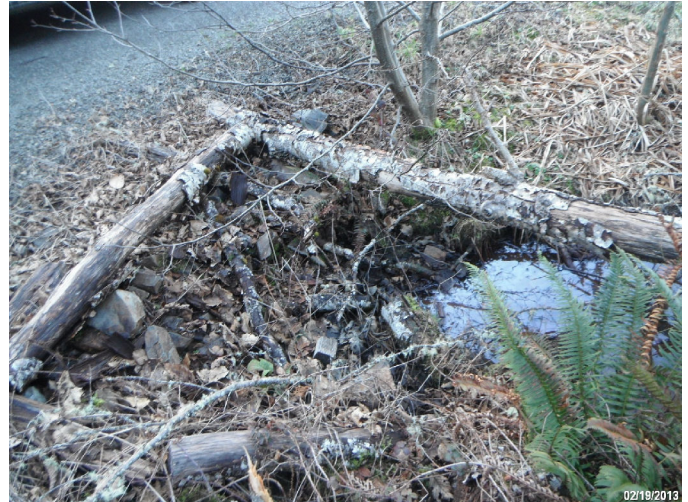
Photo: WILL_C4_0080 Route: 802
Metal Culvert 30ft long 24in dia. 1ft deep
Asset# NA

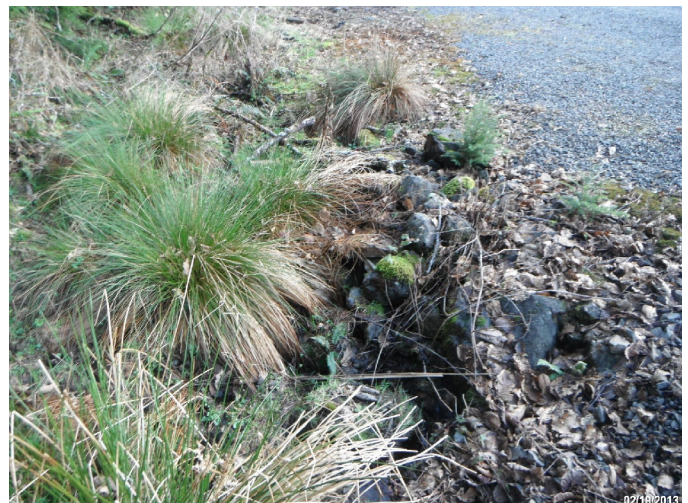
Photo: WILL_C4_0082 Route: 802
Metal Culvert 50ft long 24in dia. 1ft deep
Asset# NA

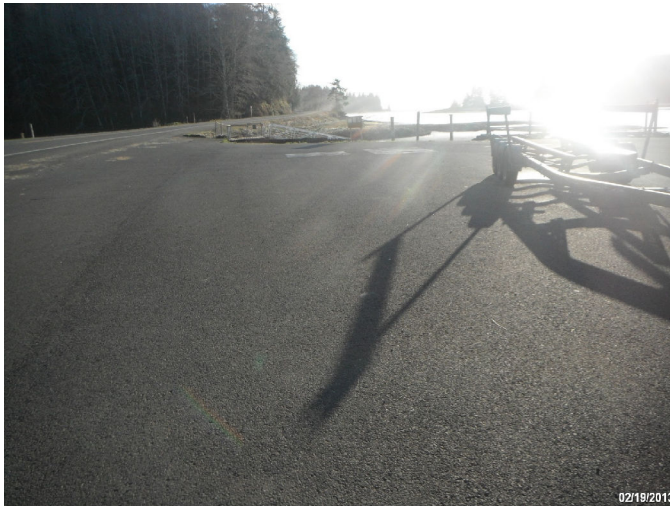
Photo: WILL_C4_0085 Route: 900
Boat Ramp WILL_C4_0086

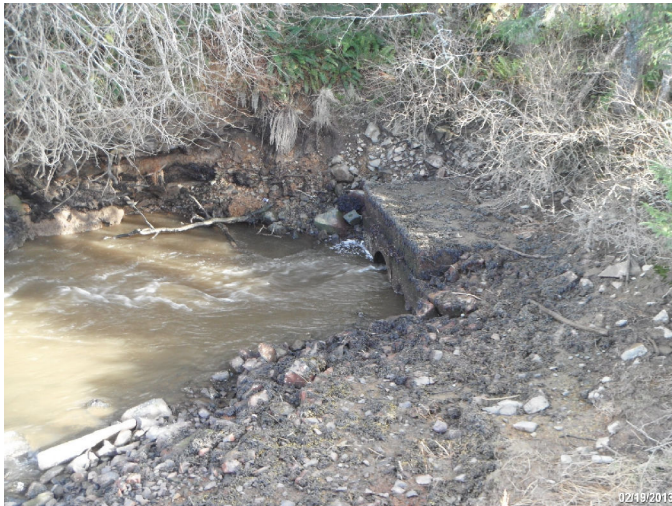
Photo: WILL_C4_0057 Route: 904
Concrete Culvert 60ft long 36in dia. 12ft deep
Asset# NA

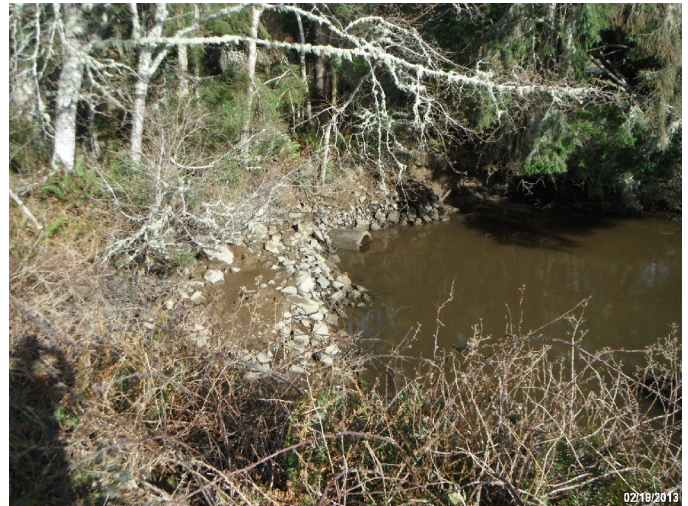
Photo: WILL_C4_0058 Route: 904
Concrete Culvert 60ft long 36in dia. 12ft deep
Asset# NA
